United Nations Transitional Administration in East Timor

SCHEDULE 1

Existing Regional Telecommunication Assets and Infrastructure

October 2000
Version 1

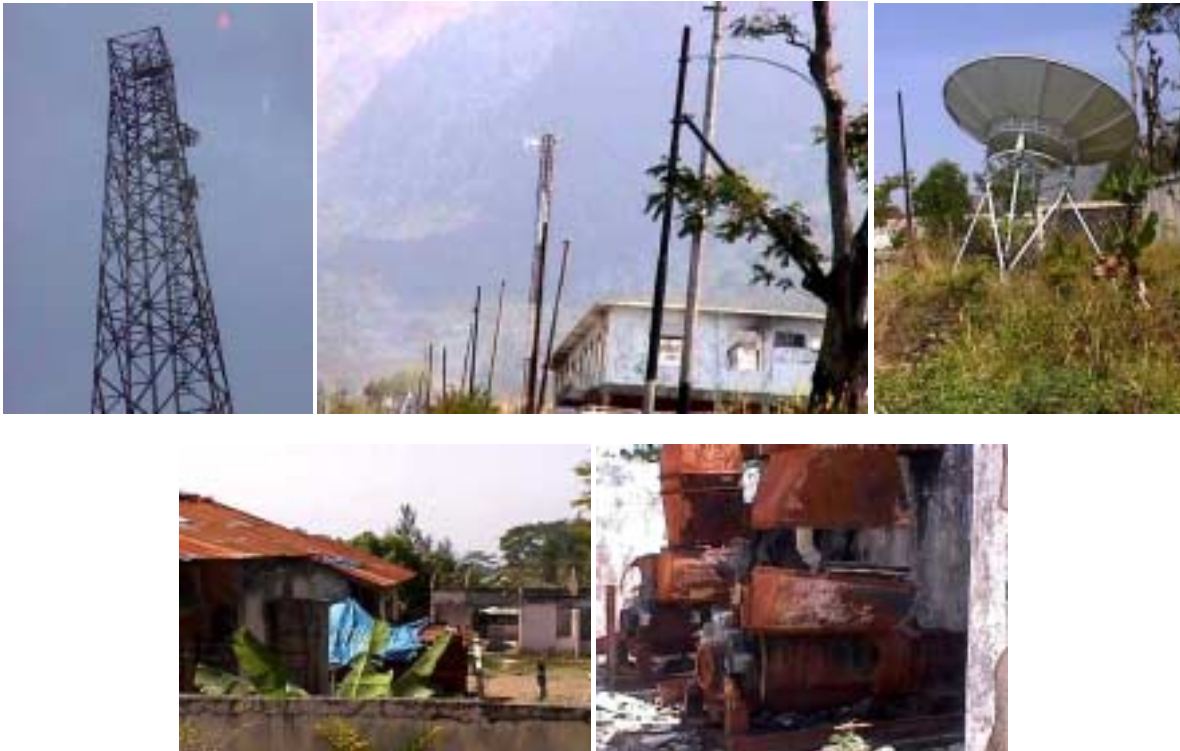
The exchange building and the plant house have been destroyed and need to be demolished and rebuilt. All electronic equipment was destroyed. The generator sets have been destroyed, the fuel tanks have sustained no visible damage. The tower shows no visible damage. The outside cable plant has been largely stolen, the poles have not been damaged.

Overall condition: Very heavy damage

AINARO TOWER, OSP POLES, SATELLITE ANTENNA, SERVICE HOUSES AND GENERATOR HOUSE

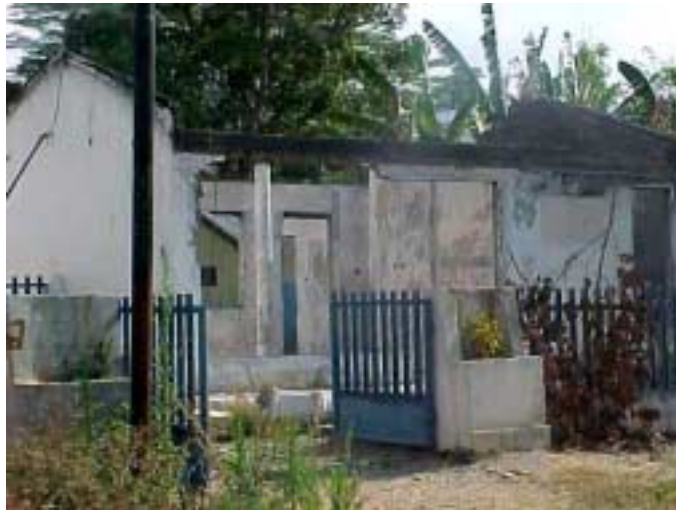
A fire in the exchange building heavily damaged the buildings and destroyed the exchange and all electronic and electric equipment including the batteries. The building will need extensive repairs.

GLENO TRANSMISSION RACK, SERVICE COMPLEX,

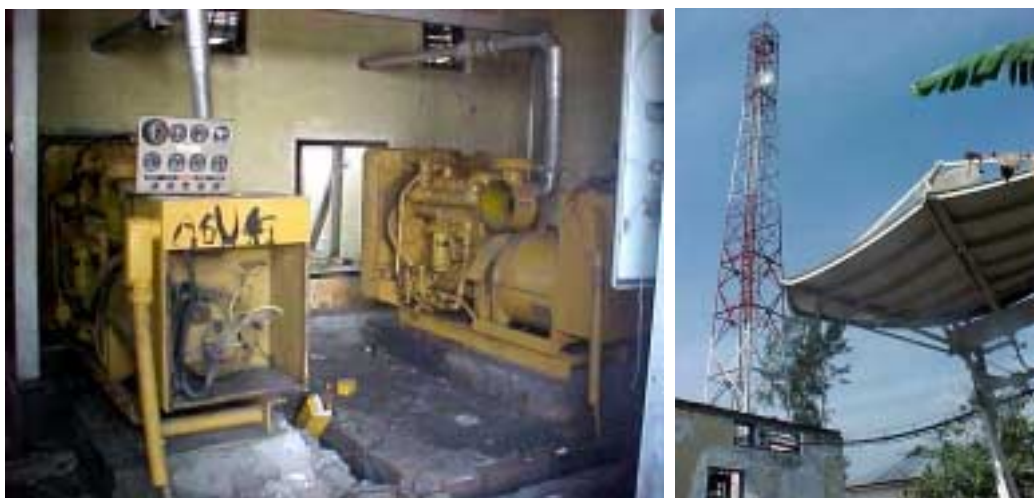
The satellite antenna, radio link antenna and radio tower sustained no visible damage.

The diesel generators sustained some mechanical but no fire damage and need repair. The diesel tanks show no visible damage.

GLENO GENERATOR ROOM, RADIO TOWER

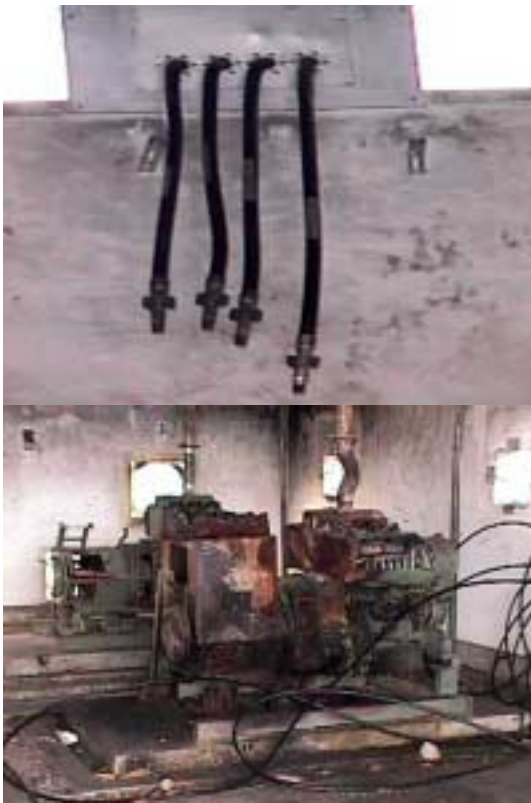
The building was burned and needs repair. All electronic equipment was destroyed or de-installed. Strong soil erosion next to building, stability of foundations need to be evaluated. Tower, antennas and feeders show no visible damage. One generator set was burned and can not be repaired, the second generator set needs repair. The fuel tank show no visible damage. Overall condition: High damage.

HATAUDO RF CABLES FROM TOWER, GENERATOR ROOM

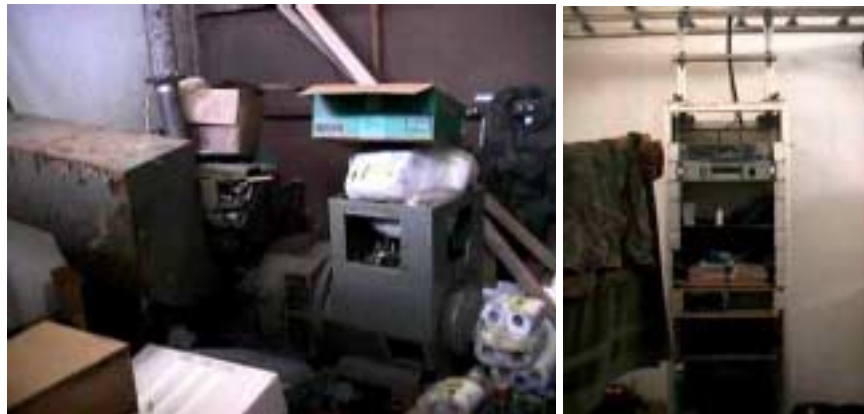
Electronic equipment has been de-installed and removed. Both gensets need repair, the tank has no visible damage. The tower and grid antenna are in very good condition. The solar panel has no visible damage and was in use at the time of survey to re-charge batteries of a Portuguese Peace Keeping Force unit. The batteries have no acid.

HOHONARO GENERATOR ROOM AND TRANSMISSION ROOM

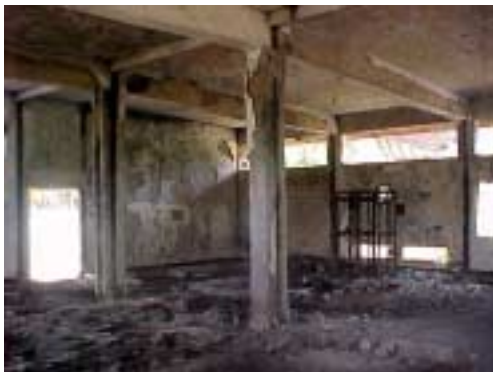
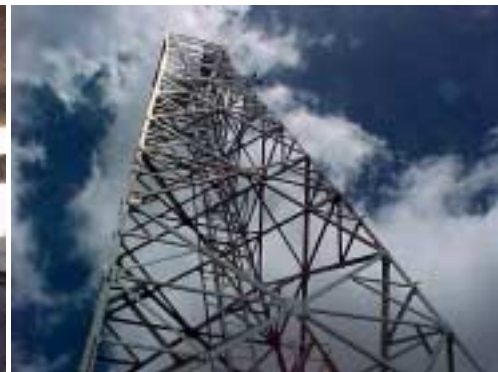
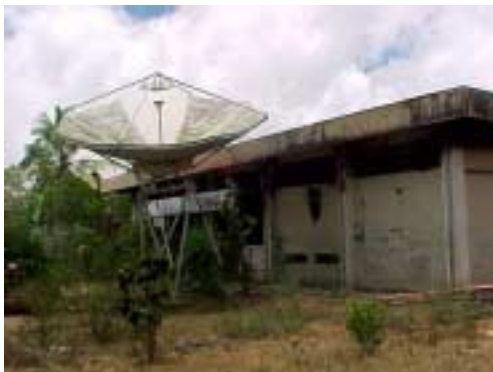
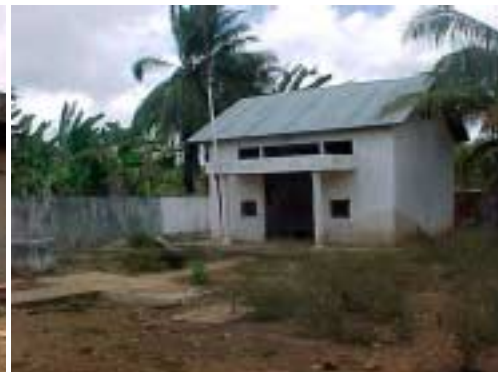
A fire in the main building damaged the buildings and destroyed the exchange and all electronic and electric equipment including the batteries.

The satellite antenna, radio link antenna and radio tower sustained no visible damage. The feeders have been damaged. The building will need extensive repairs.

The diesel generators house was burned the generator have been destroyed.

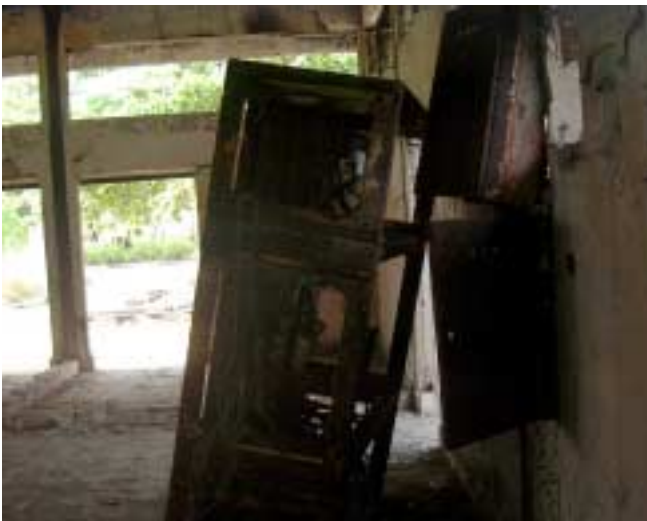
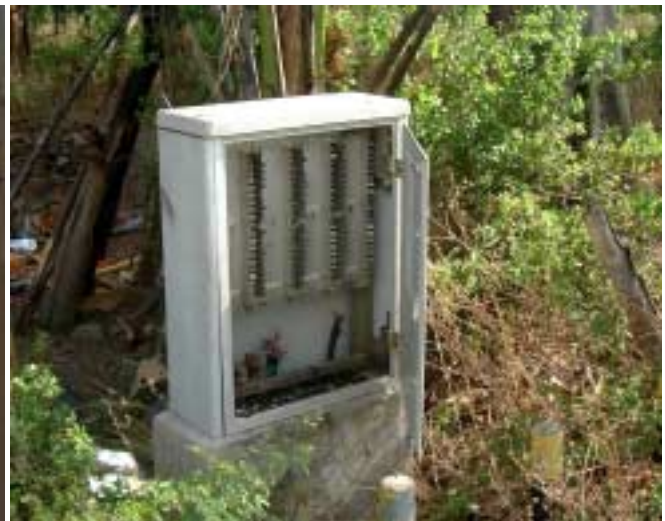
Most of the equipment has been de-installed and shipped away. The exchange building was burned and needs extensive repair. The plant house (which includes bathrooms and power plant) was not burned and needs basic repair. The satellite antenna and feeder have no visible damage. The tower shows no visible damage. The generator set have been shipped away. The diesel tanks have no visible damage. The outside plant has sustained no visible damage.

OCUSSI EXCHANGE ROOM AND OSP FEEDER-POINT CABINET

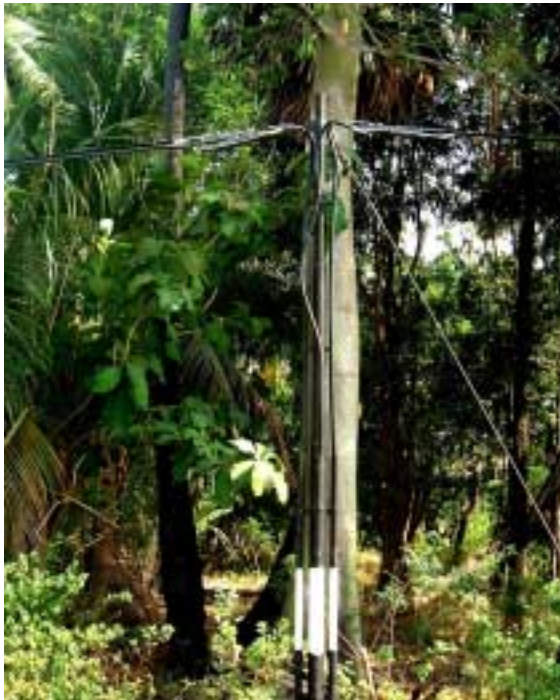
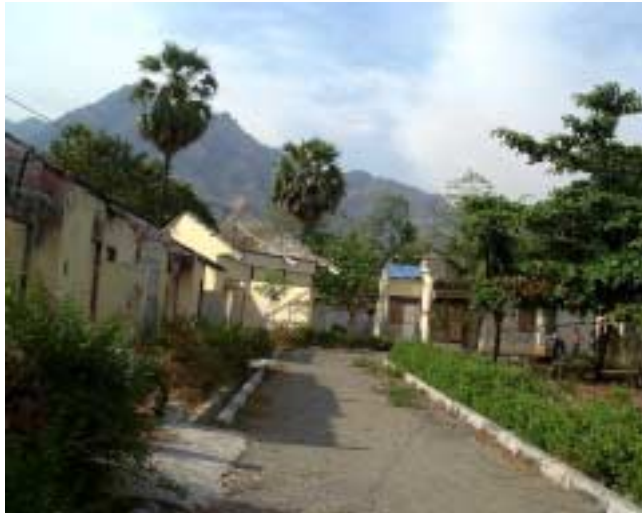
OCUSSI SECONDARY OSP NETWORK AND TELCO SERVICE COMPLEX

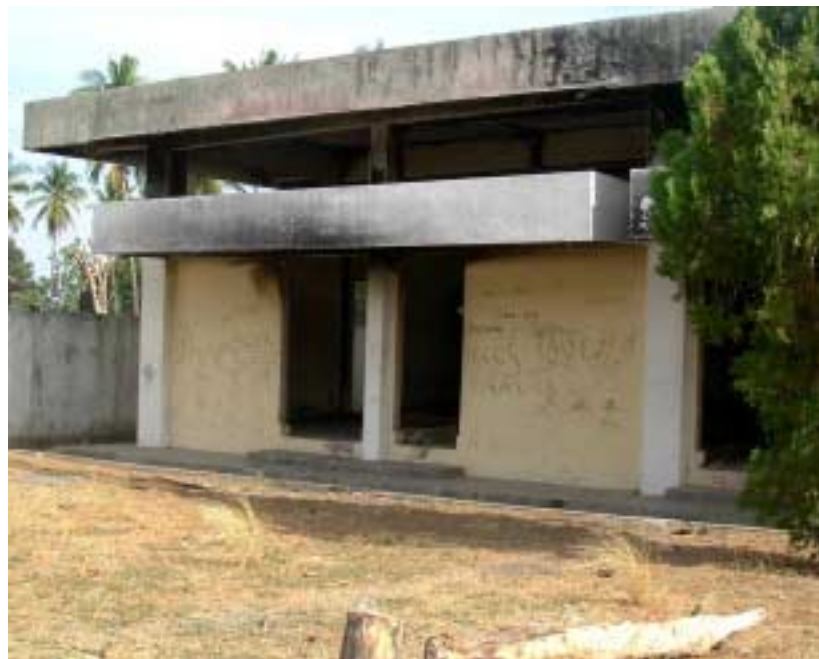
OCUSSI EXCHANGE BUILDING

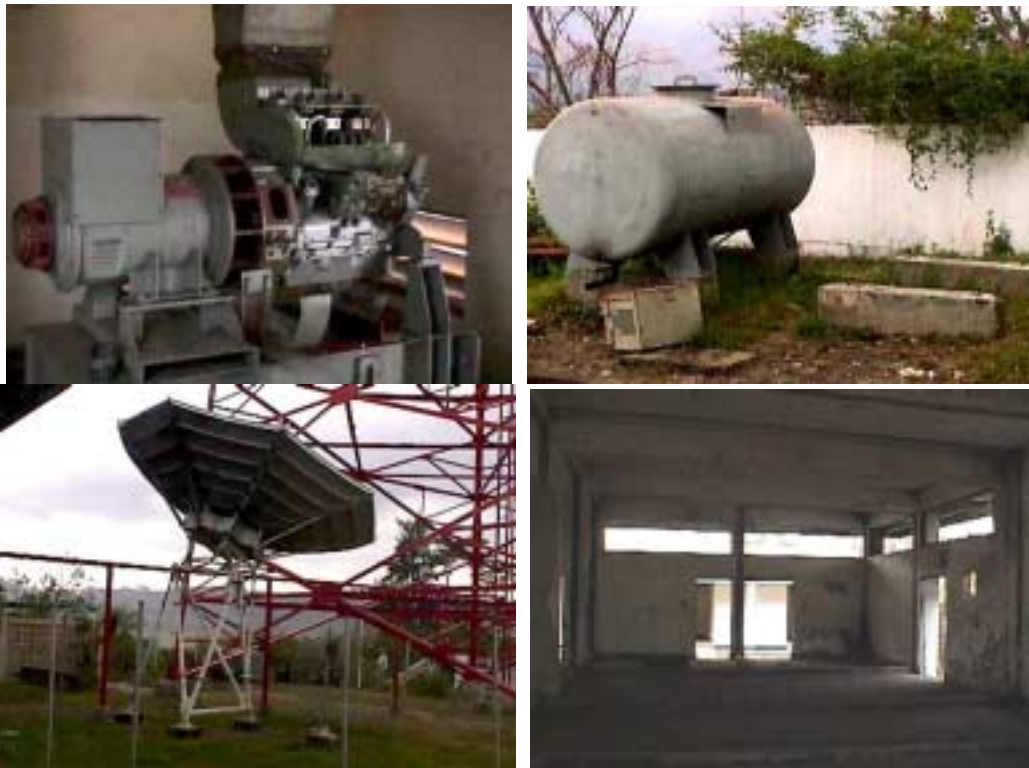
The exchange room and service buildings were burned and need extensive repairs. All electronic equipment had been de-installed. The feeders from the satellite antenna and the antennas on the tower had been cut at the bottom. The tower and the radio antenna show no visible damage. One of the two generator sets has been burned and can not be repaired. The other generator set needs extensive repairs. One of the 2 fuel tanks was moved from its original position and left on site. The outside plant has sustained no visible damage. Access at all times by 2WD vehicle. Overall condition: High damage

SAME GENERATOR ROOM, DIESEL TANK, SATELLITE ANTENNA AND EXCHANGE ROOM

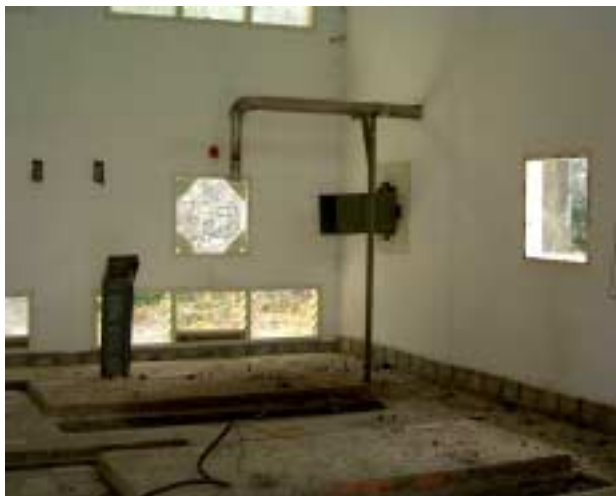
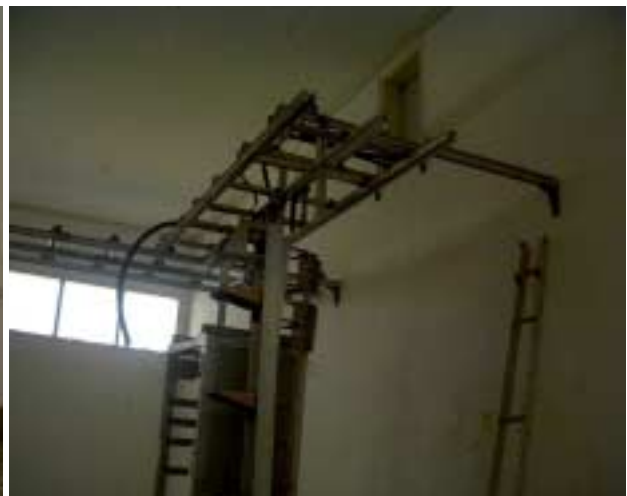
Somoro was under installation or commissioning when it was abandoned. Building and tower are in excellent condition. All equipment had been de-installed. Somoro was obviously designed to connect Ocussi via West Timor, as the orientation of the one radio antenna (155°) suggests. Overall condition: Unfinished site with no damage. All civil works completed.

SOMORO GENERATOR ROOM AND TRANSMISSION ROOM

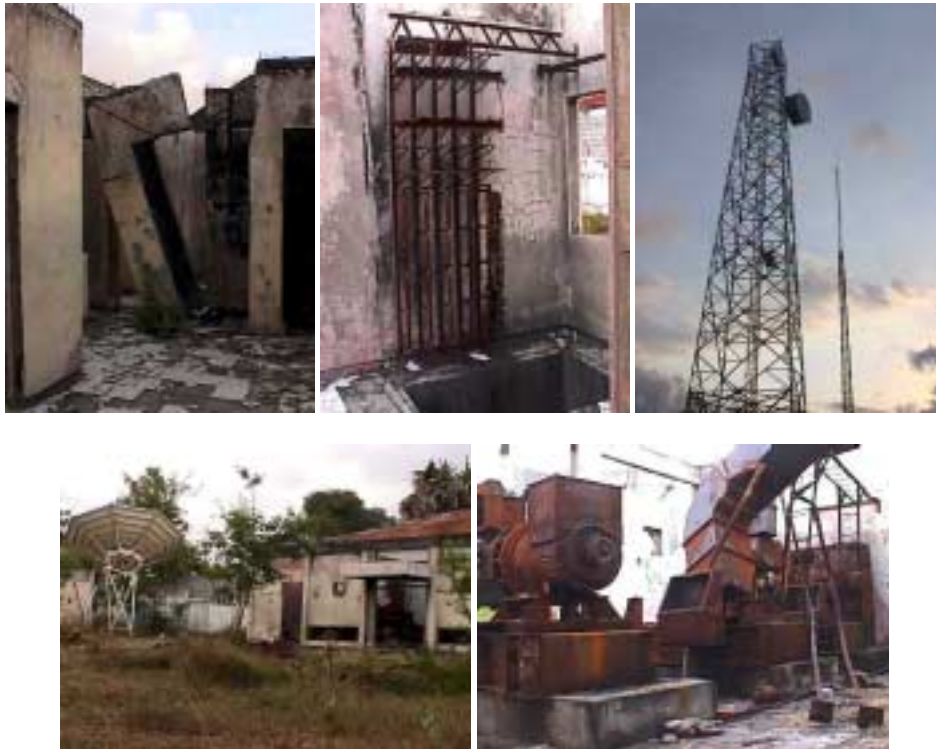
The exchange building was destroyed and need to be demolished and re-built. The plant house has been damaged extensively, generators were destroyed, fuel tanks have been removed. The tower and the feeders from the tower to the exchange building have no visible damage. The satellite antenna has no visible damage. All electronic equipment has been destroyed. The outside plant has sustained no visible damage.

Suai exchange building, MDF room, radio tower, satellite antenna and generator room

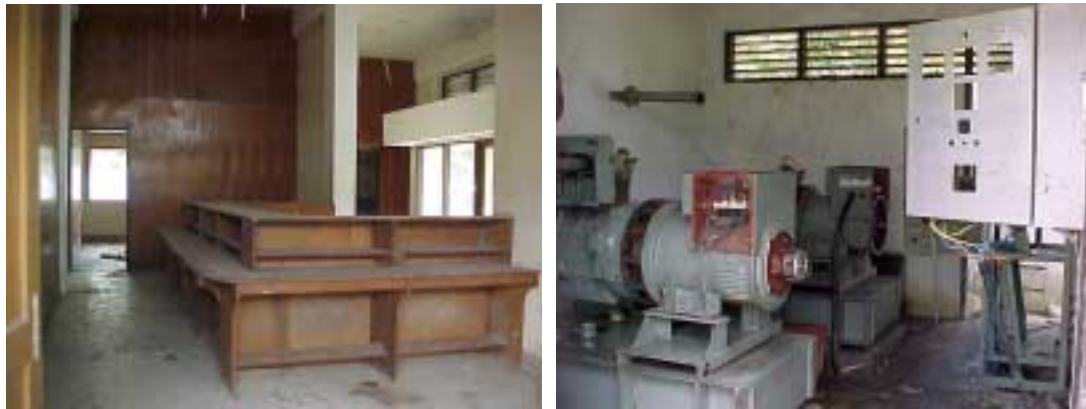
The inside of the exchange building was damaged; the building structure remained intact. The electronic equipment sustained extensive damage and need replacement, the generator sets need medium-level repair, the electric switchboard needs replacement; the fuel tank sustained no visible damage. The tower and the radio antenna show no visible damage. Tower and feeders and outside cable plant have no visible damage.

VIQUEQUE RECEPTION HALL AND GENERATOR HOUSE

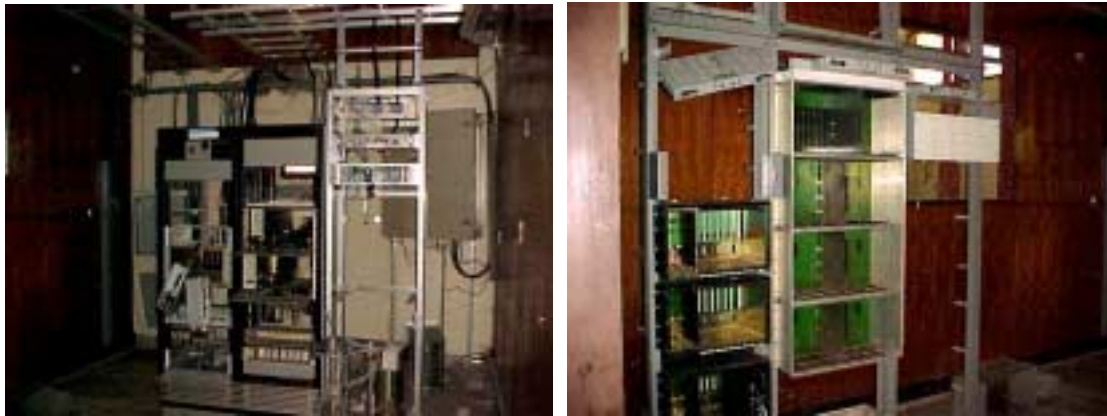
VIQUEQUE TRANSMISSION ROOM AND EXCHANGE ROOM
