United Nations Transitional Administration in East Timor

SCHEDULE 1

Existing Regional Telecommunication Assets and Infrastructure

October 2000
Version 1

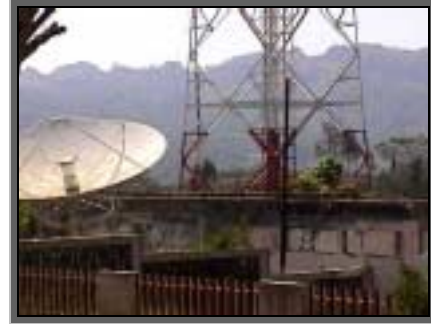
Ainaro exchange site

The exchange building and the plant house have been destroyed and need to be demolished and rebuilt. All electronic equipment was destroyed. The generator sets have been destroyed, the fuel tanks have sustained no visible damage. The tower shows no visible damage. The outside cable plant has been largely stolen, the poles have not been damaged.

Overall condition: Very heavy damage

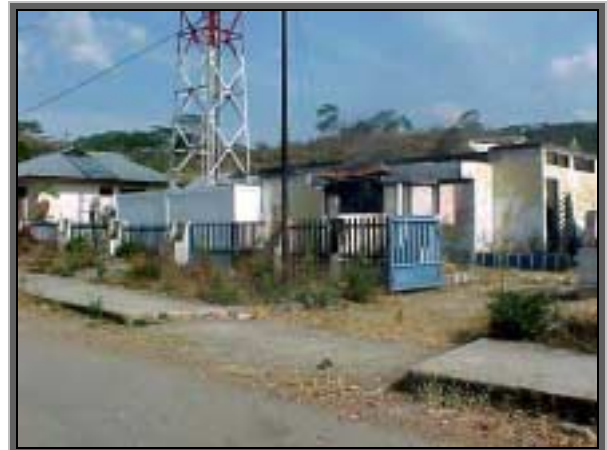
Gleno Exchange Site

A fire in the exchange building heavily damaged the buildings and destroyed the exchange and all electronic and electric equipment including the batteries. The building will need extensive repairs.

The satellite antenna, radio link antenna and radio tower sustained no visible damage.

The diesel generators sustained some mechanical but no fire damage and need repair. The diesel tanks show no visible damage.

Overall condition: Heavy damage

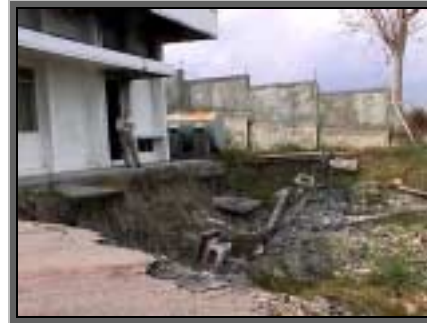
Hataudo Repeater Site

The building was burned and needs repair. All electronic equipment was destroyed or de-installed. Strong soil erosion next to building, stability of foundations need to be evaluated. Tower, antennas and feeders show no visible damage. One generator set was burned and can not be repaired, the second generator set needs repair. The fuel tank show no visible damage. Overall condition: High damage.

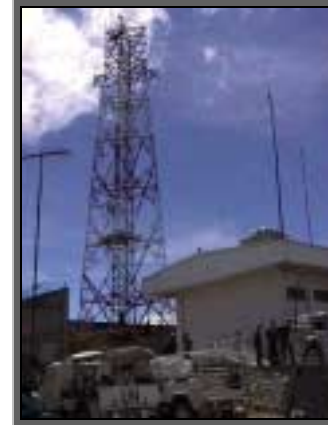
Electronic equipment has been de-installed and removed. Both gensets need repair, the tank has no visible damage. The tower and grid antenna are in very good condition. The solar panel has no visible damage and was in use at the time of survey to re-charge batteries of a Portuguese Peace Keeping Force unit. The batteries have no acid.

Overall condition: medium level damage

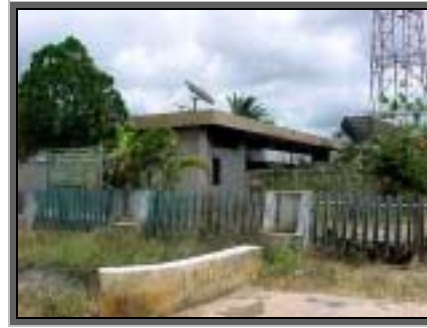
A fire in the main building damaged the buildings and destroyed the exchange and all electronic and electric equipment including the batteries.

The satellite antenna, radio link antenna and radio tower sustained no visible damage. The feeders have been damaged. The building will need extensive repairs.

The diesel generators house was burned the generator have been destroyed.

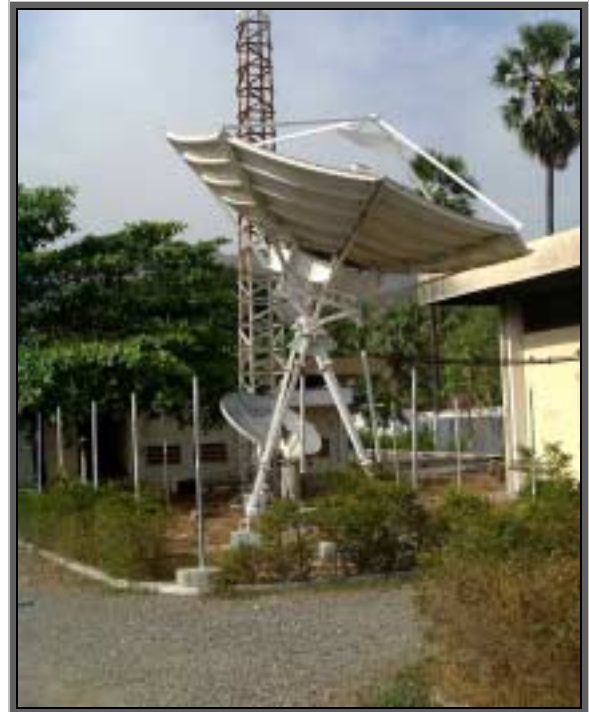
Most of the equipment has been de-installed and shipped away. The exchange building was burned and needs extensive repair. The plant house (which includes bathrooms and power plant) was not burned and needs basic repair. The satellite antenna and feeder have no visible damage. The tower shows no visible damage. The generator set have been shipped away. The diesel tanks have no visible damage. The outside plant has sustained no visible damage.

Overall condition: High level damage

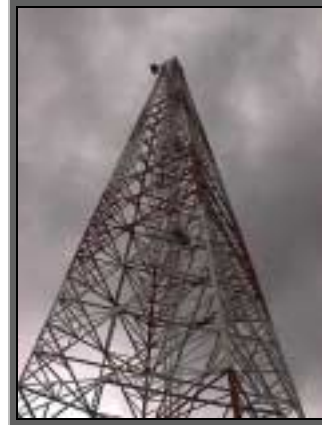
Same Exchange Site

The exchange room and service buildings were burned and need extensive repairs. All electronic equipment had been de-installed. The feeders from the satellite antenna and the antennas on the tower had been cut at the bottom. The tower and the radio antenna show no visible damage. One of the two generator sets has been burned and can not be repaired. The other generator set needs extensive repairs. One of the 2 fuel tanks was moved from its original position and left on site. The outside plant has sustained no visible damage. Access at all times by 2WD vehicle. Overall condition: High damage

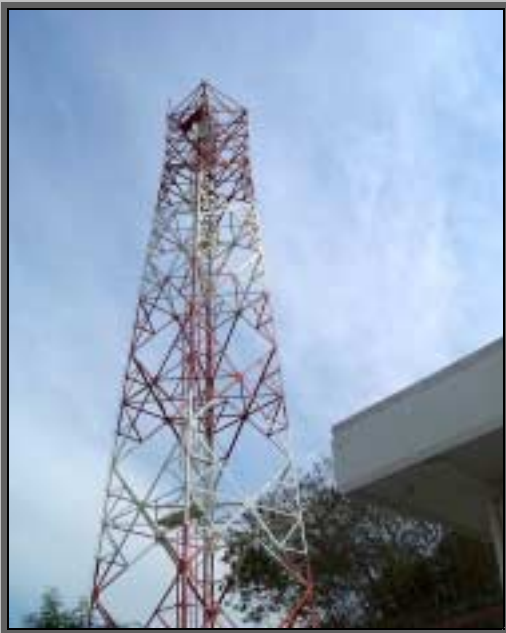
Somoro Repeater Site (Pante Makasar)

Somoro was under installation or commissioning when it was abandoned. Building and tower are in excellent condition. All equipment had been de-installed. Somoro was obviously designed to connect Ocussi via West Timor, as the orientation of the one radio antenna (155°) suggests. Overall condition: Unfinished site with no damage. All civil works completed.

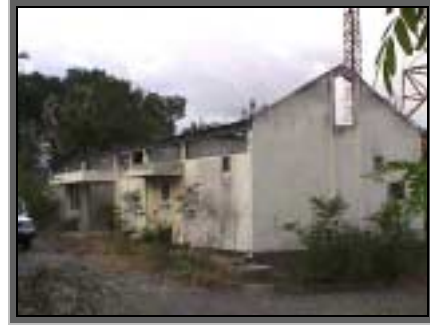
The exchange building was destroyed and need to be demolished and re-built. The plant house has been damaged extensively, generators were destroyed, fuel tanks have been removed. The tower and the feeders from the tower to the exchange building have no visible damage. The satellite antenna has no visible damage. All electronic equipment has been destroyed. The outside plant has sustained no visible damage.

Overall condition: High-level damage

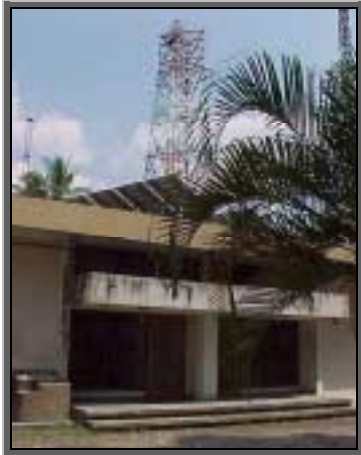
The inside of the exchange building was damaged; the building structure remained intact. The electronic equipment sustained extensive damage and need replacement, the generator sets need medium-level repair, the electric switchboard needs replacement; the fuel tank sustained no visible damage. The tower and the radio antenna show no visible damage. Tower and feeders and outside cable plant have no visible damage.
